A minerals research contract report June 1982

DEMONSTRATING THE NOISE CONTROL OF A COAL PREPARATION PLANT VOLUME II:

LONG TERM TREATMENT EVALUATION

Contract H0155155 Bolt Beranek and Newman Inc. 10 Moulton Street Cambridge, MA 02238

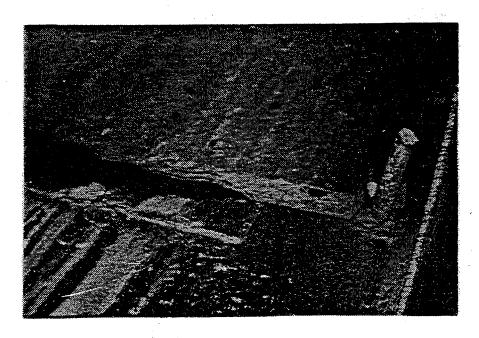
months. The original pad was replaced with a 1-1/2 in. thick urethane pad which was at least as effective in reducing the impacts and provided significantly improved service life. Figures 14 and 15 show the pad shortly after installation (Nov. 1976) and after 1-1/2 years of service (July 1978). The pad eventually provided in excess of 2 years of service before requiring replacement.

FIG. 14. URETHANE IMPACT PAD INSTALLED ON PICKING TABLE (NOV. 1976).

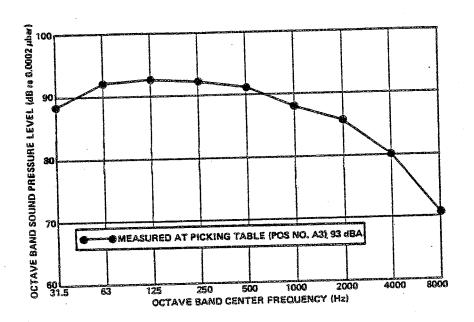
Table 3 summarizes the results of the sound level data taken during this project. As can be seen in this table, the sound levels around the primary shaker and picking table areas generally fall between those measured prior to treatment and those measured after the initial treatment. The increase in sound levels during the final visit over those measured just after treatment in 1977, alongside the primary shaker, is due in part to the previously mentioned increase in large material passing over the screen. As mentioned in Sec. 2.2.1 the impact of the large material dropping from one level to the next was also audible due to wear of the 1/2 in. Armaplate impact pads between the screens. Since the effect of the worn Armaplate strips on the primary shaker has a small effect on the picking table operator's position and the impact pad at this position was in good condition during the final measurements, the increase in sound levels at the picking table over the 1977 data is primarily attributed to the previously mentioned operational changes. Figure 31 shows the sound pressure level spectrum at the picking table operator's position (A3) measured in 1980.

FIG. 31. SOUND PRESSURE LEVELS MEASURED AT PICKING TABLE OPERATOR'S POSITION.

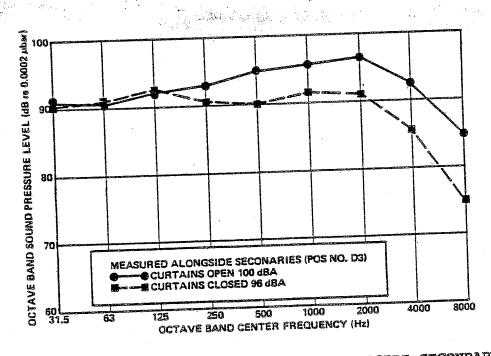
FIG. 32. SOUND PRESSURE LEVELS MEASURED ALONGSIDE SECONDARY SCREENS.

The increase in coarse material also affects the sound levels around the secondary shakers. The upper curve in Fig. 32 was measured at position D3 with the curtains around the screens open* to simulate the "before" condition. The A-weighted sound level for this test was 100 dBA or 3 dBA more than that measured at the beginning of the program. The difference between the upper and lower curves in Fig. 32 also illustrates that although the sound levels have increased somewhat due to changes in plant operation, the curtains are still providing close to the original 4-5 dB of noise reduction (almost 4 years after initial installation).

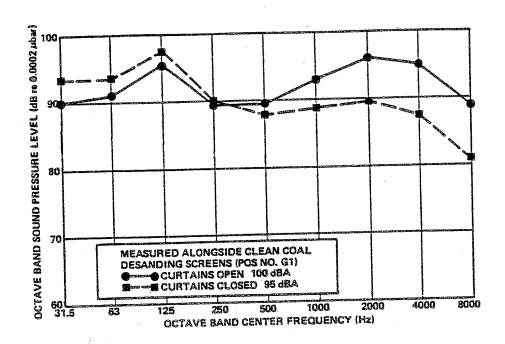
The sound levels measured at the clean coal desanding shakers again illustrate the effect of changes in plant operation. Prior to any treatments the sound levels alongside the shakers (position Gl) were 96-97 dBA. Figure 33 shows the sound levels measured at this position in 1980. The upper curve represents the spectrum measured with the curtains completely* open, and is 3 to 4 dBA higher than the original sound levels. This correlates well with the increases resulting from the processing

FIG. 33. SOUND PRESSURE LEVELS MEASURED ALONGSIDE CLEAN COAL DESANDING SCREENS.

of surface coal measured at other locations in the plant. The difference between the upper and lower curves in Fig. 33 indicates the current performance of the curtains, which is still comparable to that achieved in 1977.

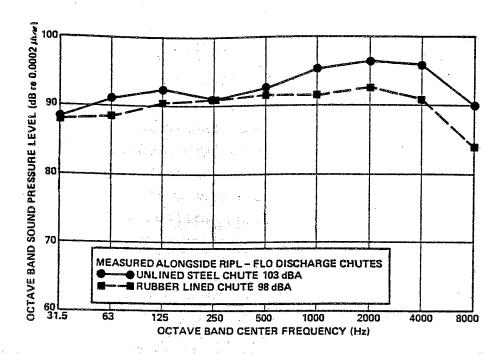
Although the Ripl-Flo* screens were not operating at full capacity during the final visit to the plant, it was possible to obtain "close-in" data at the discharge chutes to measure the effectiveness of the rubber chute liners. Figure 34 shows the spectra measured 6 in. from both lined and unlined discharge

FIG. 34. SOUND PRESSURE LEVELS MEASURED 6 IN. FROM RIPL-FLOT DISCHARGE CHUTES.

chutes. As can be seen, the 1/2 in. rubber chute lining is still providing a 4-5 dBA reduction in the noise radiated by the chutes.

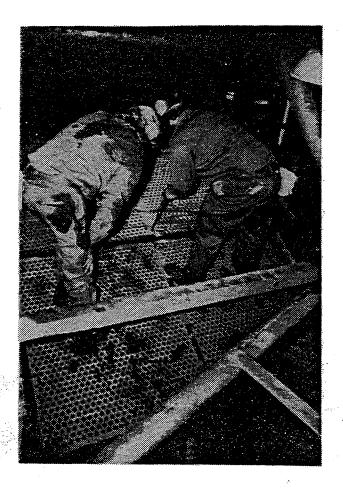
flow of raw coal over both materials was equal, the screen deck materials were alternated on each screen (Fig. 37). That is, the 40 durometer rubber-clad feed panel on screen Tl was followed by a 48 durometer rubber-clad panel, which was followed by another 40 durometer panel, etc. The order of the panels on screen T2 was reversed (starting with a 48 durometer rubber-clad panel) to normalize the flow of raw coal over the two materials. Originally, no impact pads were installed on either feed panel.

FIG. 37. INSTALLATION OF RUBBER-CLAD SCREEN DECKS IN PLANT A.

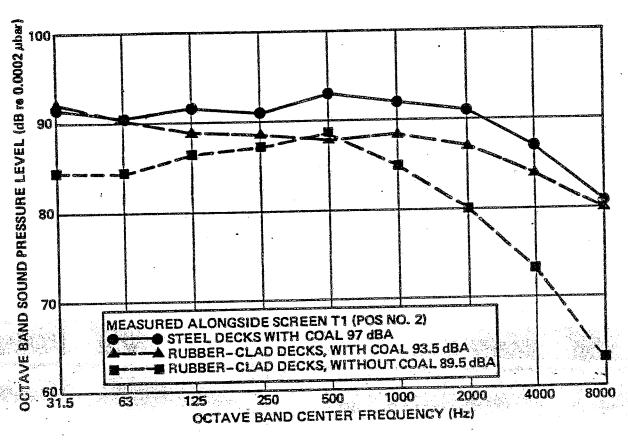
Figure 38 shows the sound spectra measured approximately 5 ft from the side of screen Tl (Position No. 2 in Fig. 35) before and after treatment. As can be seen in the figure, the A-weighted sound level was reduced by 3-1/2 dBA. This noise reduction is quite good considering that the infeed and outfeed chutes, the lower deck, and the drive mechanism remained untreated. The level of drive mechanism noise is illustrated by the lowest curve in Fig. 38.

SOUND PRESSURE LEVELS MEASURED ALONGSIDE RAW COAL FIG. 38. SCREENS IN PLANT A.

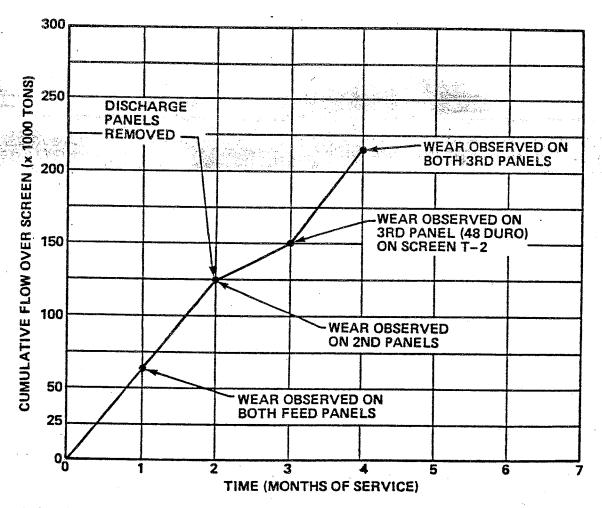
In terms of durability, neither the vulcanized 48 durometer nor the cold-bonded 40 durometer screen decks provided the anticipated service life. In addition to the wear at the impact point on the infeed panels observed shortly after installation, significant wear was evident on the second panel on each screen during the second visit to the plant (19 January 1979) and on the third panel by the fourth visit (6 March 1979). This is summarized in Fig. 39 which plots the cumulative tonnage versus time. The wear observed during these visits was described as a combination of wear and delamination similar to that observed at the Georgetown Plant.

FIG. 39. SERVICE HISTORY OF TEST DECKS IN PLANT A.

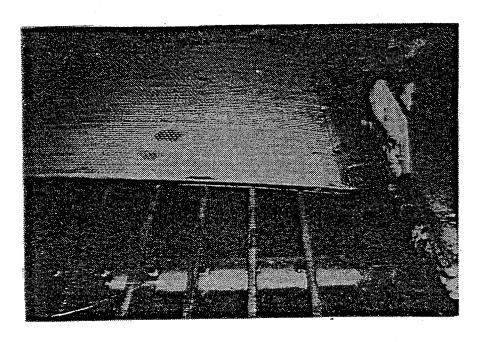
The test decks were installed during the midnight shift on October 26, 1978. Since the Hewitt-Robins screens used wedge pins instead of bolts to secure the clamping bars (see Fig. 41), the installation time was substantially reduced. The total installation time for all 8 screen panels was 3 hours, which was

FIG. 41. CLAMPING BAR ARRANGEMENT ON TEST SCREENS IN PLANT B.

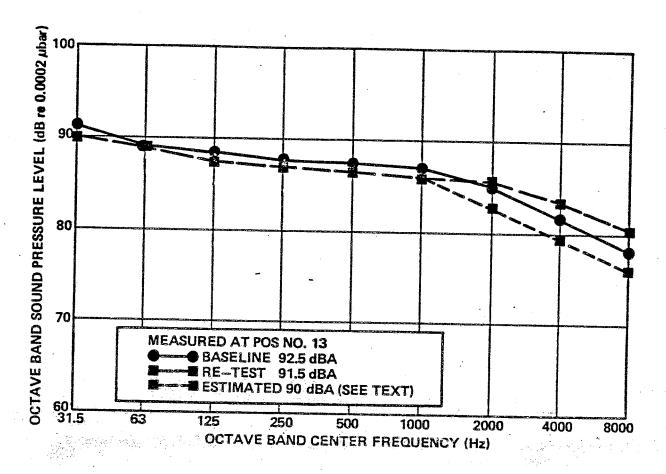
FIG. 42. SOUND PRESSURE LEVELS MEASURED ON RAW COAL SCREENING FLOOR OF PLANT B.

shows the sound spectra at Position No. 13 (see Fig. 40) under various conditions. The spectrum labeled "Baseline" (92.5 dBA) represents the sound levels measured under full operation with the original woven wire decks. The spectrum labeled "Re-Test" (91.5 dBA) represents the sound levels measured at a later date with three elastomer-clad panels in place on each screen (see discussion below regarding the re-test in this plant).

screening floor were higher during the re-test than during baseline tests; and the second is that only three of the four panels
were elastomer-clad. The first reason indicates that some basic
change took place since the original measurements were made.
This change could be due to increased tonnage, changes in water
spray nozzles, changes in water pressure or some other unknown
factor. Nevertheless, this change results in the re-test spectrum being higher than expected (in fact, they are even higher
than the baseline levels which is in contrast to previous experience with elastomer-clad decks). It is possible to correct for
this by reducing the high frequency portion of the re-test spectrum by an amount equal to the net change observed near the
untreated screens. This was done and the corrected spectrum,
labeled "Estimated," is also shown in Fig. 42.

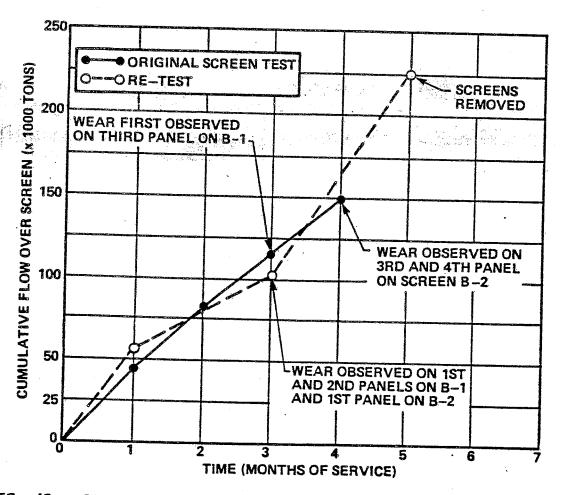
Figure 43 summarizes the monitoring of the test decks in Plant B. This deterioration was described by the manufacturer's representative as an apparent failure of the bond between the rubber layer and the steel punch plate (again, similar to the experience at the Georgetown Plant). The conclusion was verified during a visit to the plant in July 1979, 9 months after the installation. Figure 44 illustrates how the rubber layer, being held in the photo, had separated from the steel punch plate. This was considered a premature failure since the separated rubber layer was still relatively thick, indicating that if it hadn't separated it would have still been serviceable.

FIG. 43. SERVICE HISTORY OF TEST DECKS IN PLANT B.

appear to be markedly different than observed during the initial tests. This can be seen by comparing the observations in Fig. 43. While the timing of the wear resembled that observed during the initial tests, the wear patterns did not exhibit the same distinct evidence of delamination. In these tests, the wear appears to be due to abrasion and tearing (or cutting). This can be seen in Figs. 45 and 46 where the elastomer is worn thin and abraded in contrast to the previous tests where the elastomer separated from the steel before significant abrasive wear could take place.

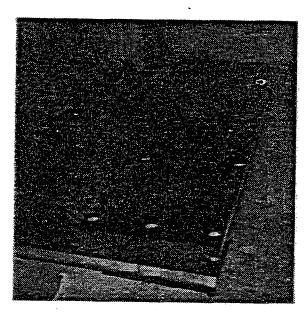
rubber-clad decks, and an impact pad was also fitted to the feed panel (see Fig. 48).

FIG. 48. SOLID IMPACT PAD ON URETHANE-CLAD FEED PANEL IN PLANT C.

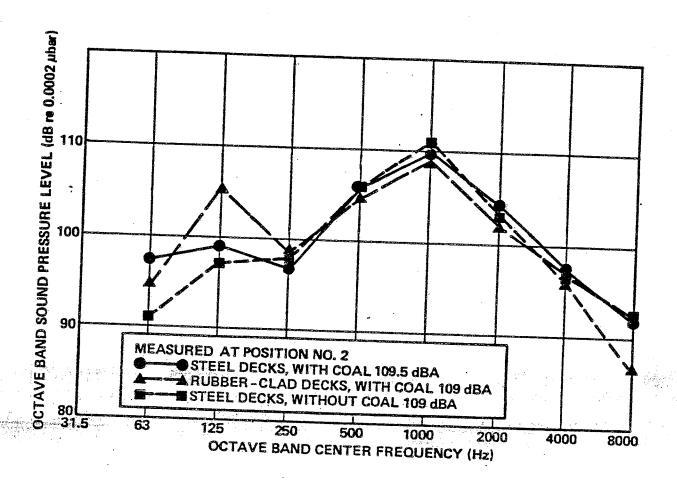
Figure 49 summarizes the sound level data measured between the screens (Position 2 in Fig. 47) before and after the installation of the elastomer-clad decks. As can be seen by comparing the steel and elastomer-clad spectra (with coal), there was only

FIG. 49. SOUND PRESSURE LEVELS MEASURED IN CLEAN COAL SCREENING AREA OF PLANT C.

a slight change in the sound spectrum after the installation of the elastomer-clad decks. The reason for this small amount of noise reduction is evident by noting that the drive noise of these screens dominates the impact noise due to the coal flow. As a result, any reduction of the coal impact noise achieved by the installation of the elastomer-clad decks is masked by the drive noise which is not altered by the decks. It should also be noted that the drive noise of these screens is unusually high (109 dBA) and indicates that a mechanical problem may exist in the drive system.

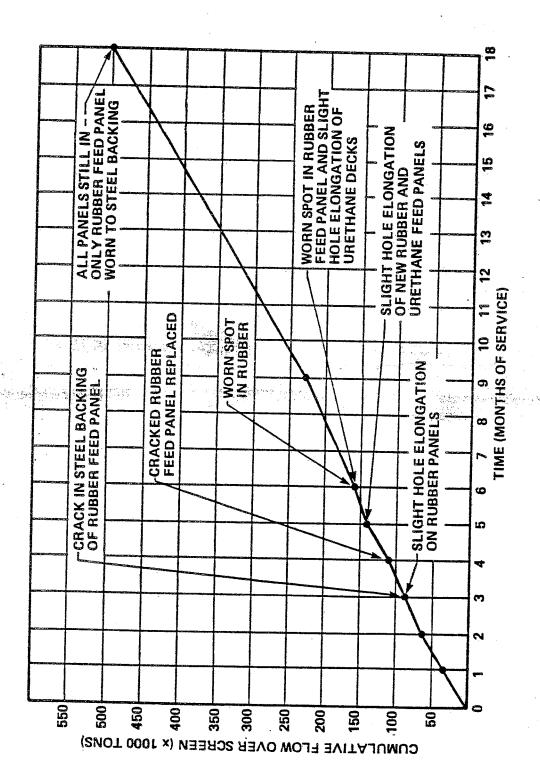
G. 50. SERVICE HISTORY OF TEST DECKS IN PLANT C.

operational and durability standpoints. The durability is illustrated by noting that most of the elastomer-clad panels (particularly the urethane panels) were in relatively good condition almost 2 years after installation, whereas the original steel decks were reported to need replacement after 6 months. Since the test decks were still in use at the end of the monitoring period, it was not possible to assess the final cost effectiveness. However, they had already outlasted the original decks by almost a factor of 4 and apparently had appreciable life remaining at the end of the monitoring period.

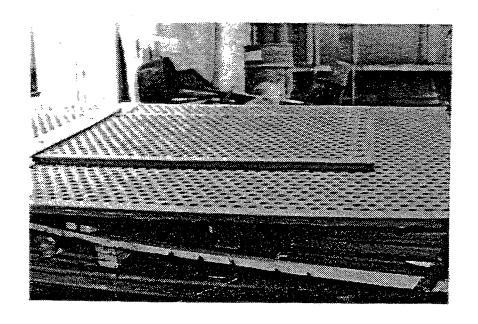
Finally, while the test decks were originally equipped with impact pads, as shown in Fig. 52, they were not used (see test results).

FIG. 52. PERFORATED IMPACT PAD ON URETHANE-CLAD FEED PANEL IN PLANT D (SEE TEXT).

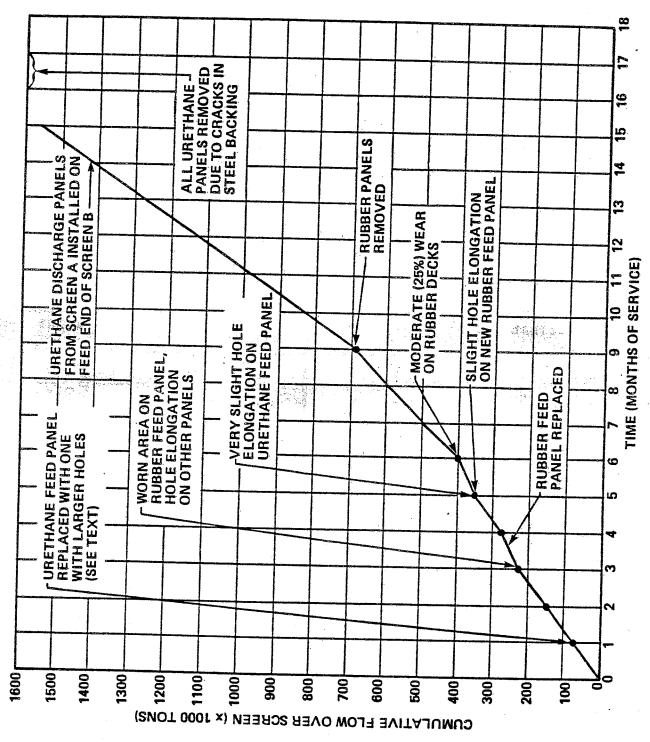
FIG. 54. SERVICE HISTORY OF TEST DECKS IN PLANT D.

Figure 54 summarizes the results of the durability monitoring. As can be seen, the rubber-clad panels exhibited some hole elongation after 3 months of service and the rubber-clad feed panel exhibited significant wear. The rubber-clad feed panel was replaced after 3-1/2 months due to excessive wear (see Fig. 55). At the end of the initial 6 month period, the thickness of the rubber-clad panels was typically 75% of the original thickness. At the end of 9 months the rubber-clad panels were worn out and removed.
